# ***S.A.F.E. Inspection Services, LLC***

## **Property Condition Report**

123 Some Street, City, PA Zip  
Inspection prepared for: Sample Report  
Date of Inspection: 3/29/2016 Time: 9:00 AM  
Age of Home: Built: Size: Square Feet  
Weather: Weather

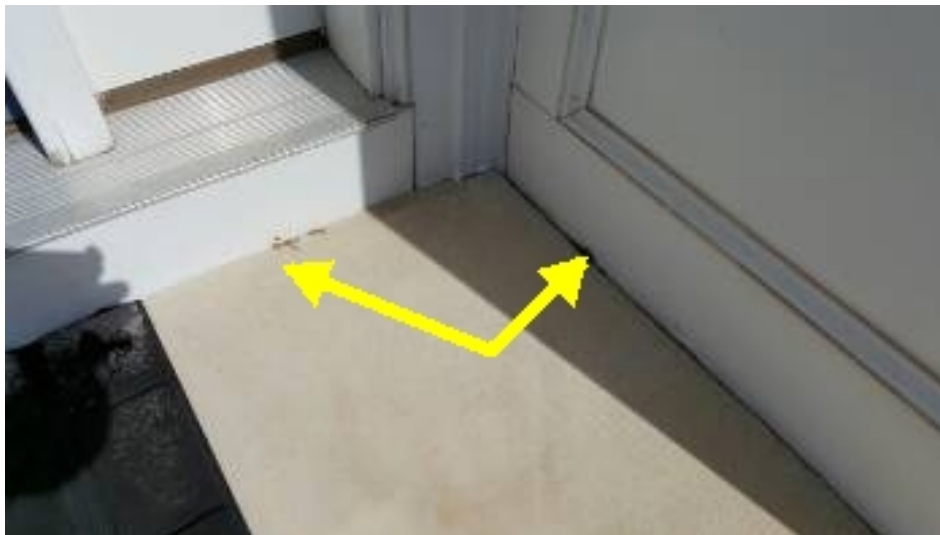
- Maintenance Suggested
- There is a gap noted between the porch and the foundation wall , suggest to properly seal the crack to prevent moisture penetration between the slab and the foundation wall

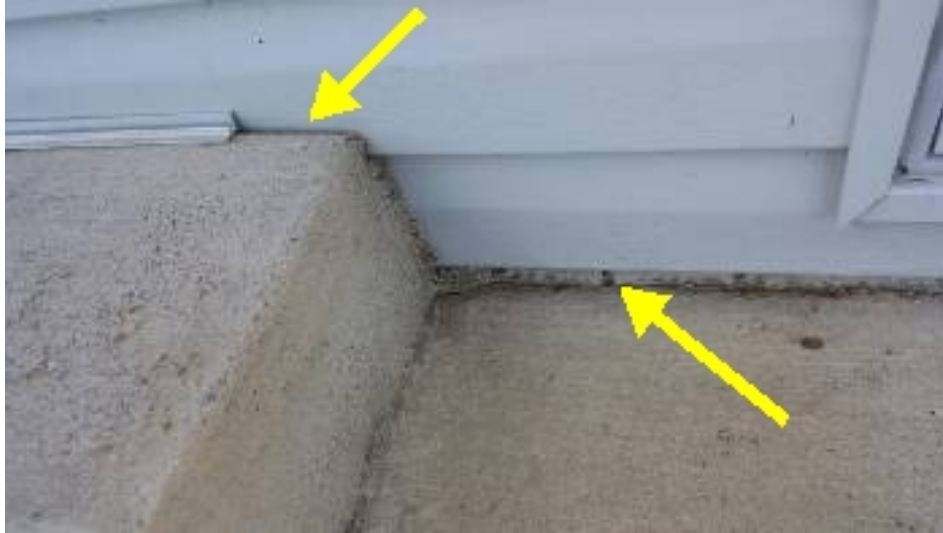
Observations: Maintenance is suggested , Patio has settled away from the structure , there is a crack noted between the patio slab and the foundation , suggest to have the crack properly sealed to help prevent water penetration into the crack and cause future settlement / damage

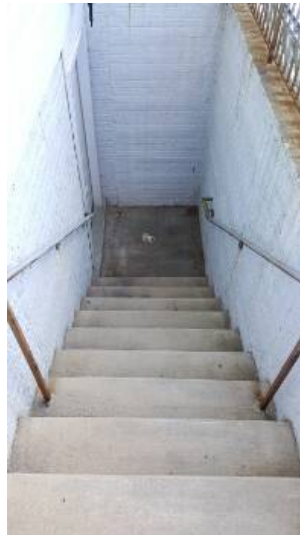
Keep the stairwell free and clear of debris and the drain cleaned out to prevent water backing up into the well

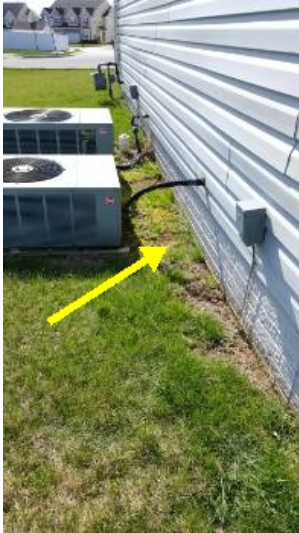
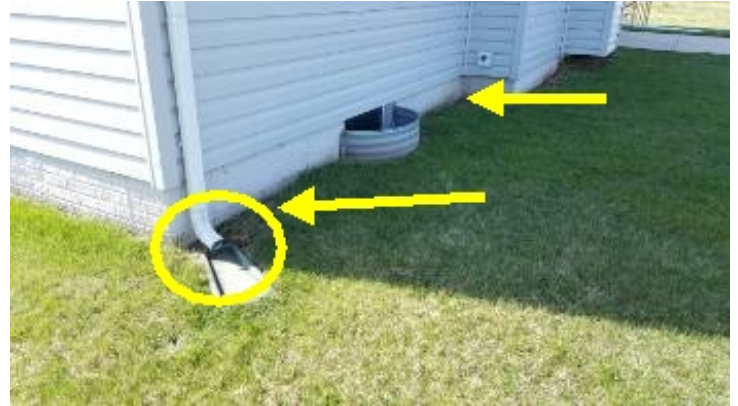
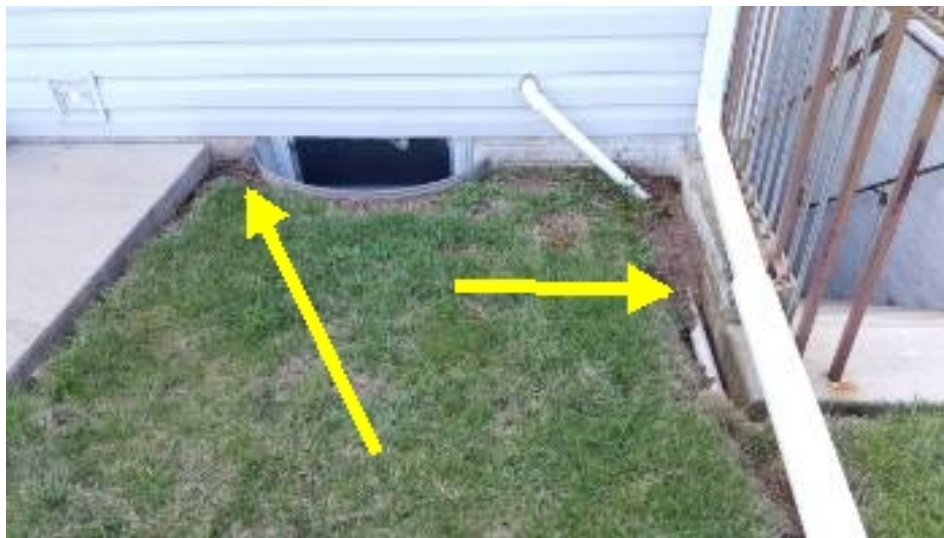
- Maintenance Suggested
- There is evidence of poor drainage and grading noted in areas throughout around the foundation walls , suggest to have the mulching / stone beds pulled away and removed from the foundation areas so the grading can be further evaluated so the low lying areas around the foundation can be properly re graded and filled in where necessary to ensure the proper drainage away from the structure to help prevent moisture / water penetration into the lower levels of the dwelling

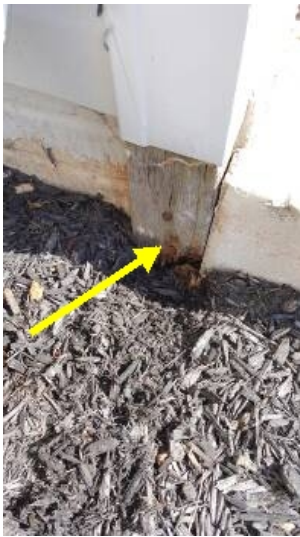
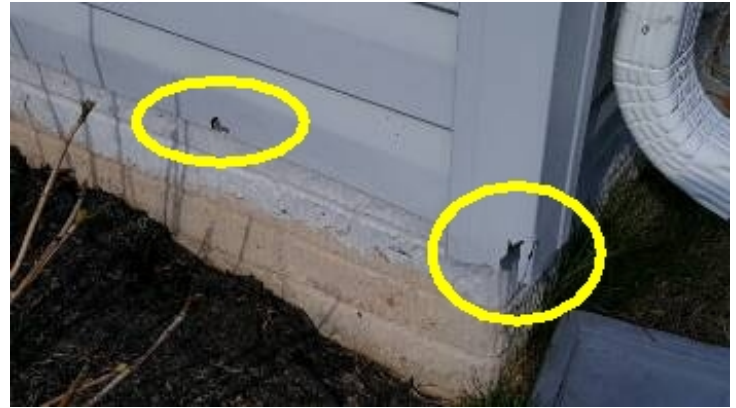
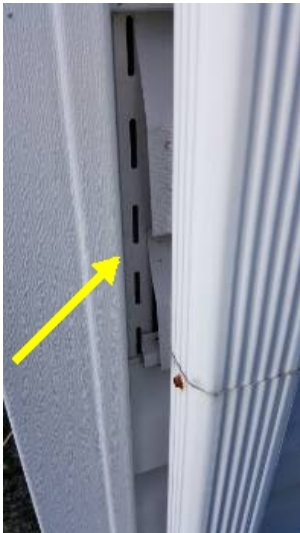
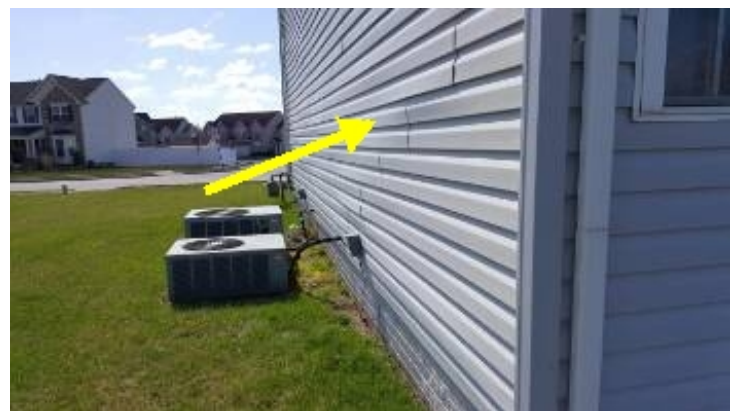
| Page 6 | CONDITION | <ul style="list-style-type: none"><li>• Suggest Repairs</li><li>• Several sections of the siding has come loose mostly along the left and right sides of the home , there are some separations in the siding at the corner along the right side and some seams are pulling apart , the rear section below the window 1st floor is damaged/loose , Suggest to have a qualified siding contractor evaluate the siding and make all necessary upgrades and repairs to ensure the future integrity and water tightness of the siding throughout.</li></ul> |

- Maintenance suggested
- Suggest to cut the former boards even with the siding along the sides of the front porch to prevent moisture wicking and or insect damages
- **Suggest Repairs**
- Several sections of the siding has come loose mostly along the left and right sides of the home , there are some separations in the siding at the corner along the right side and some seams are pulling apart , the rear section below the window 1st floor is damaged/loose , Suggest to have a qualified siding contractor evaluate the siding and make all necessary upgrades and repairs to ensure the future integrity and water tightness of the siding throughout.

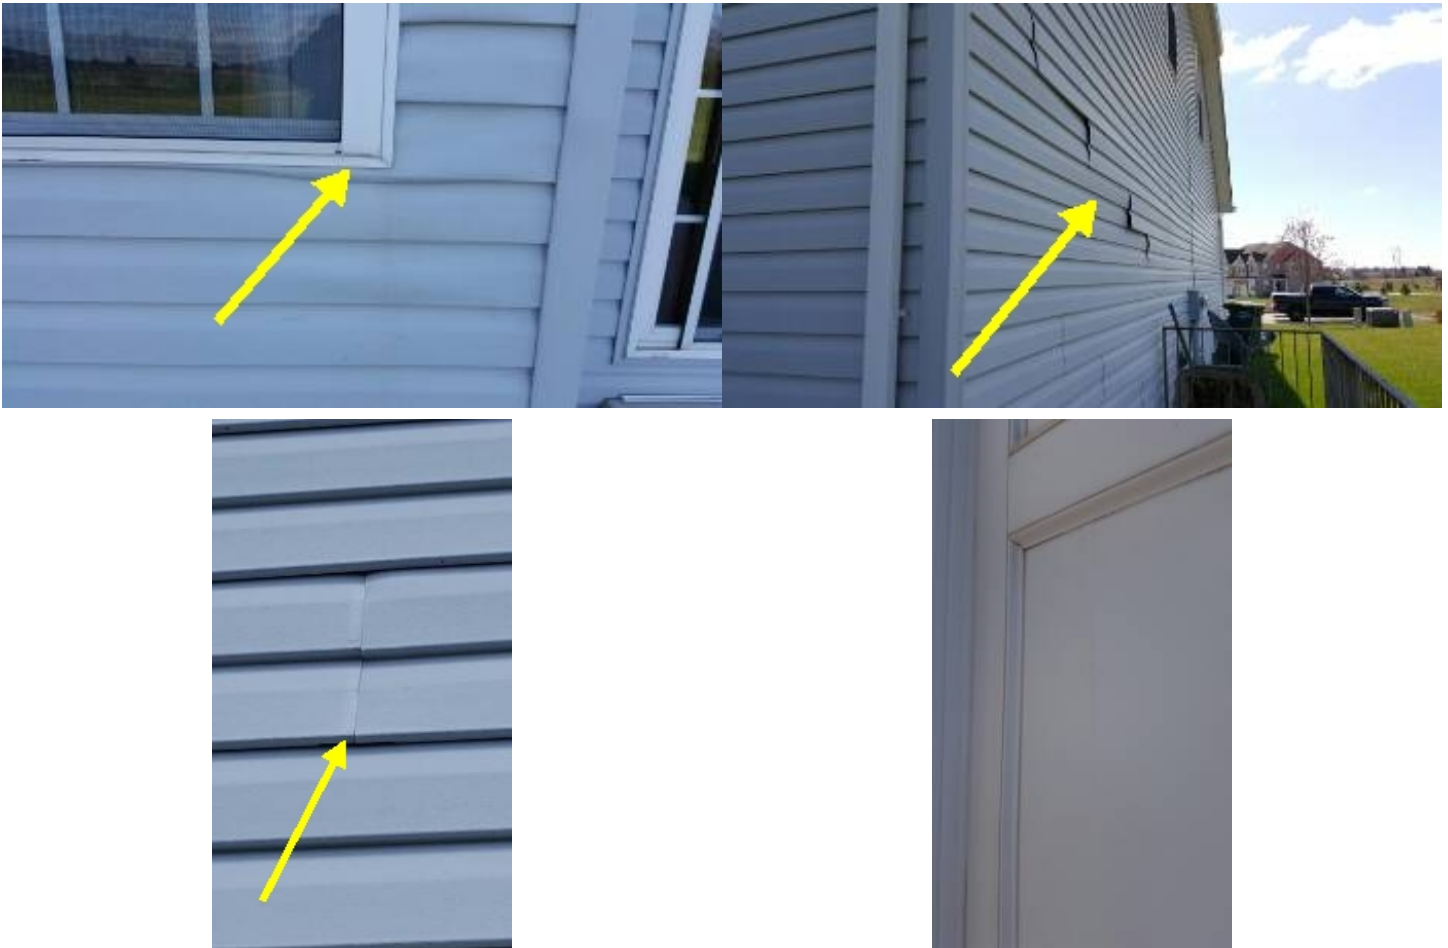
Keep areas properly sealed and painted , there is evidence of the plywood panels along the front door entrance area is warping , consider to have the areas covered with another type of low maintenance siding / cover

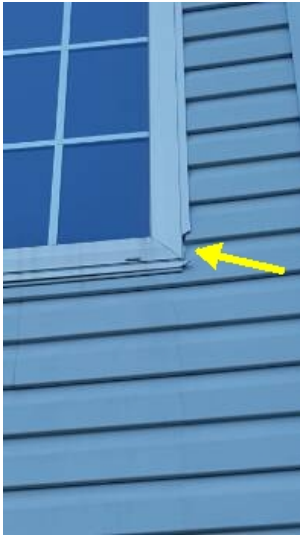
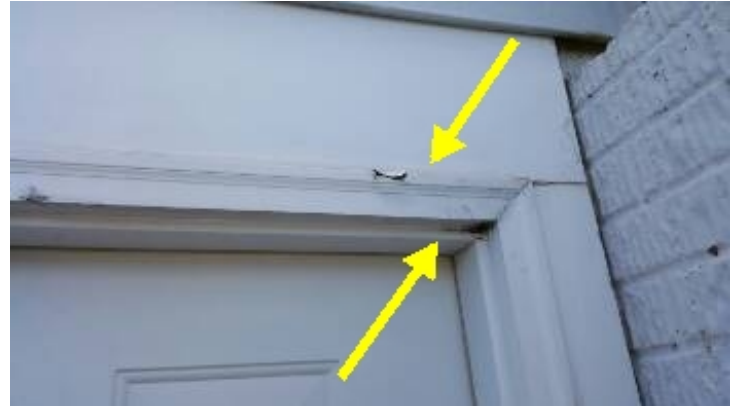
- Suggest Repairs
- There is moisture damage noted around the exterior door frame / trim along the top areas at the rear basement door in left side stairwell . Suggest to have a qualified contractor make the proper upgrades and repairs to the door to ensure the future water tightness and integrity of the door , damage may be to the interior frame as well
- Areas around the exterior doors are currently vulnerable to water penetration in and around the doors , suggest to properly seal around the exterior doors with a quality sealant (silicone) especially around the bottoms of the threshold areas / siding , and frame to ensure the water tightness and integrity in and around the doors
- The left side exterior basement door does not latch/seal properly at the door handle, suggest upgrades or repairs for proper latching and sealing of the door

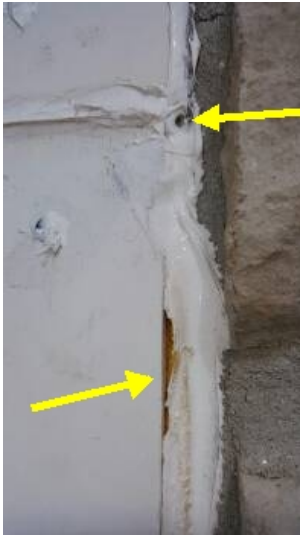
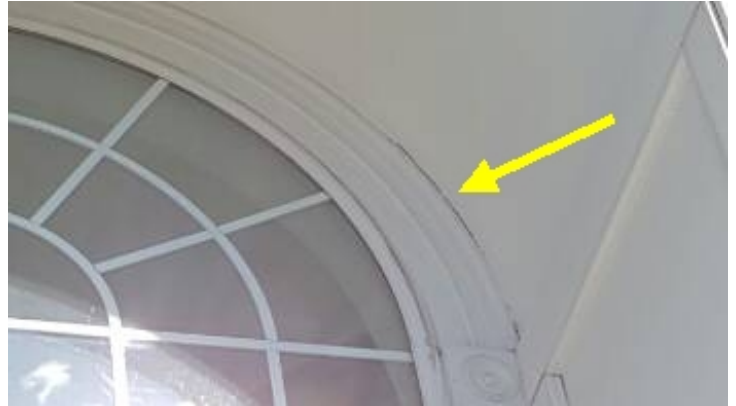
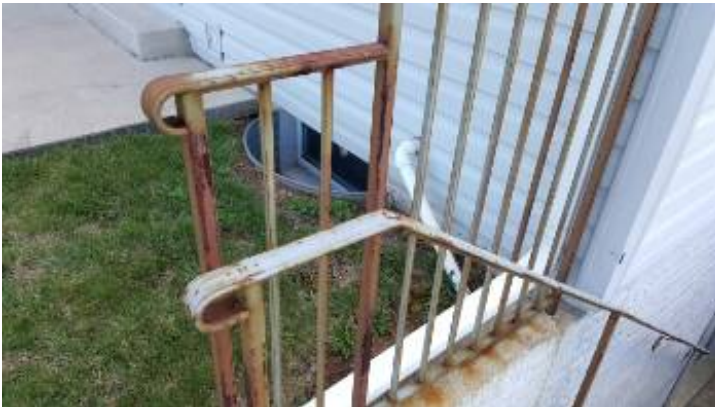
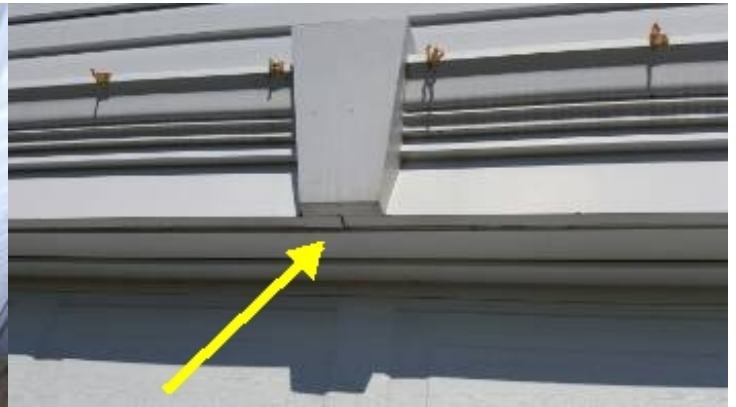
- Maintenance Suggested
- Painting on the trim and wood areas is showing signs of deterioration/need of painting , suggest to have the areas properly ,painted , and sealed to ensure the integrity and water tightness of the trimmed areas.

- Caulking is missing/deteriorating in some areas. mostly around the windows and door areas. Suggest to have the areas properly caulked and sealed , especially where two unlike surfaces meet to ensure the water tightness in and around these area.

- There is separation and some moisture damage noted above the garage vehicle door at the top areas , water appears to be penetrating through and around the top areas and down into the frame board below , there is currently no flashing installed to prevent this moisture penetration , suggest to have this area proper flashed and repaired to ensure the water tightness and integrity of the trim board area

- Exposed and rusted nails around the exterior trim areas along the front around windows and doors , suggest to have the nails set and properly pudding and painted to protect

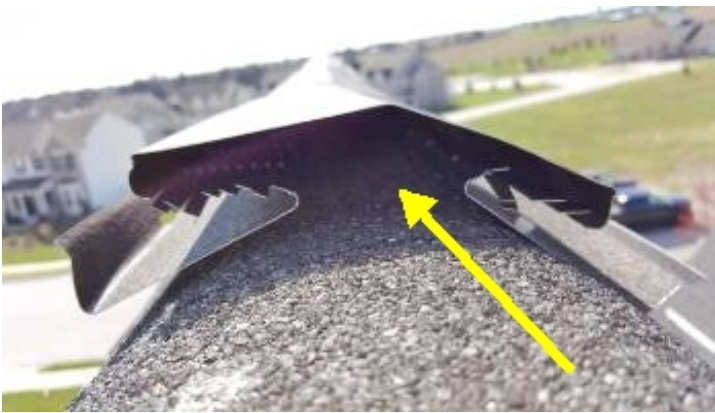
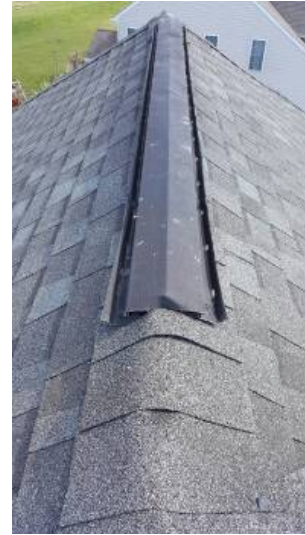
- Maintenance Suggested
- The ridge vent is missing the end caps in some areas throughout. Suggest to install the proper ridge vent caps to ensure the water tightness and keep birds and other animals from possibly entering the attic areas.
- Suggest to secure the ridge vents to the roof ridge as some nails are backing out and ridge vent is becoming loose. The maintenance should be performed to ensure the water tightness in and around the ridge vent area.
- Suggest to secure ridge vent nails and seal exposed nails along the top of the ridge vent.

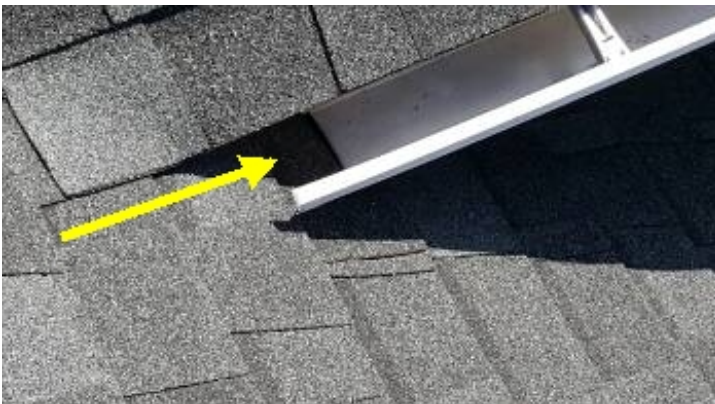
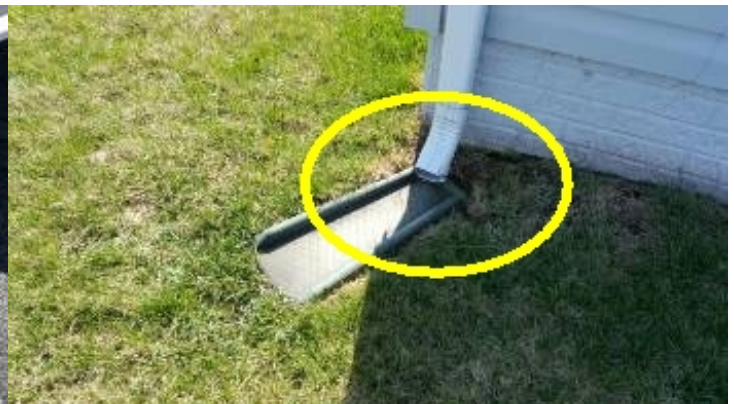
- Maintenance Suggested
- Down spouts do not properly drain water away from the foundation. Route down spouts away from the building. This will help with the water entering the foundation.
- Suggest to have open end of gutters along the front dormer cut back/out further to allow for better drainage and prevent ice jamming

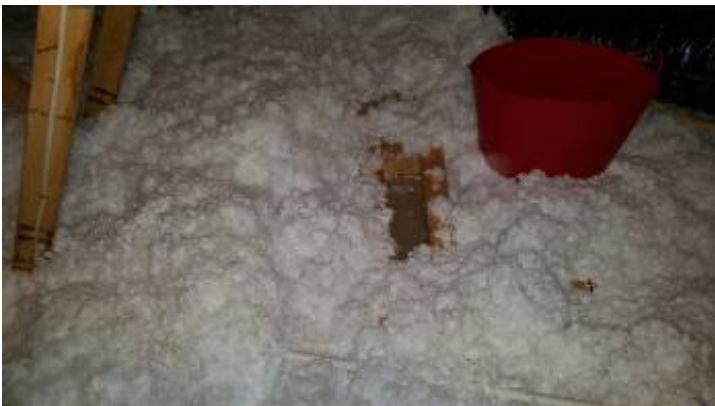
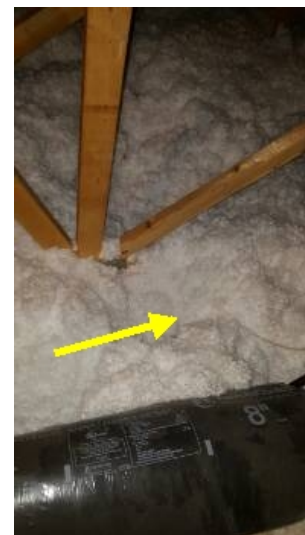
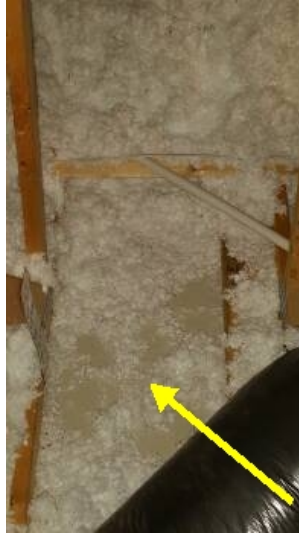
- Maintenance Suggested
- Suggest to insulate the back side of the access pull down ladder steps to prevent thermal heat loss into the attic
- Some insulation is installed unevenly or has been disturbed and moved , Suggest to have the insulation leveled out or added into these areas to ensure the proper coverage and insulation R value

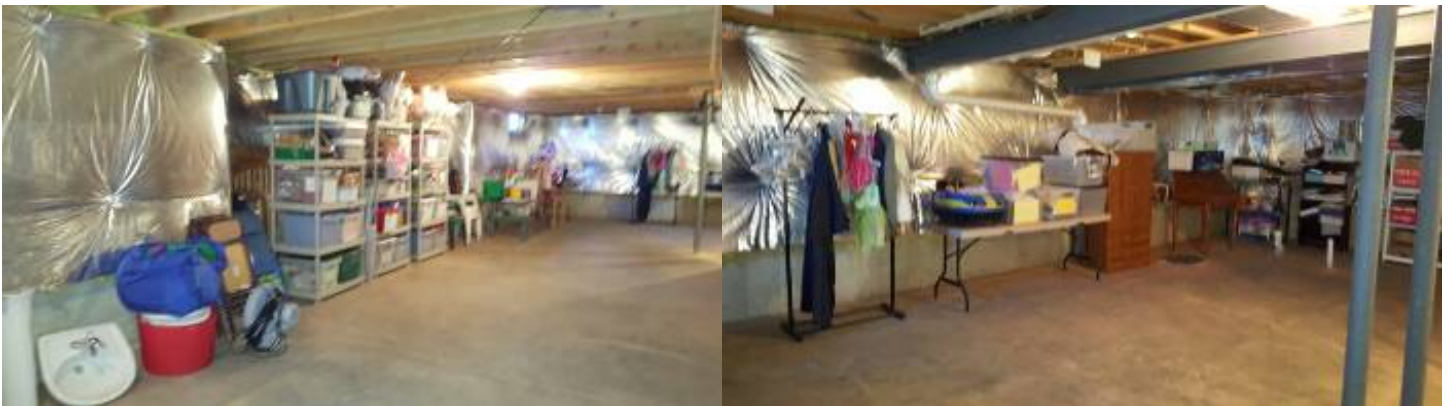
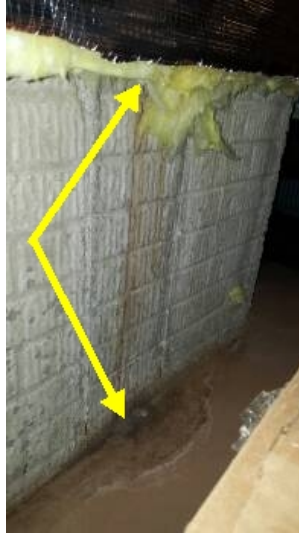
| Page 15 | FOUNDATION<br>CONDITION | <ul style="list-style-type: none"><li>• Suggest repairs</li></ul> <p>There appears to be a crack within the foundation wall along the right front foundation where there is a water stain noted on the floor below , Suggest to have a qualified contractor familiar with concrete wall repairs remove the insulation and evaluate the crack in the foundation wall and make all necessary upgrades and repairs to the foundation/crack to ensure the future water tightness and integrity of the wall, Check with the seller for any previous knowledge of the crack and or water penetration in this area.</p> |

There appears to be a crack within the foundation wall along the right front foundation where there is a water stain noted on the floor below , Suggest to have a qualified contractor familiar with concrete wall repairs remove the insulation and evaluate the crack in the foundation wall and make all necessary upgrades and repairs to the foundation/crack to ensure the future water tightness and integrity of the wall, Check with the seller for any previous knowledge of the crack and or water penetration in this area.

Evidence of a crack leaking in the front foundation wall to the right of the front entrance ,  
suggest repairs

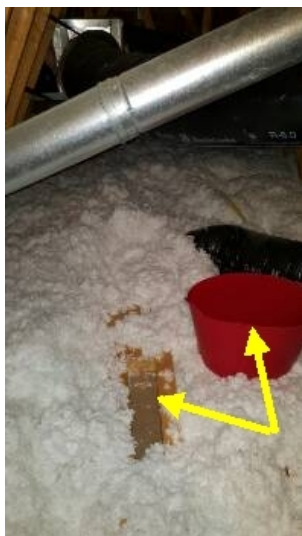
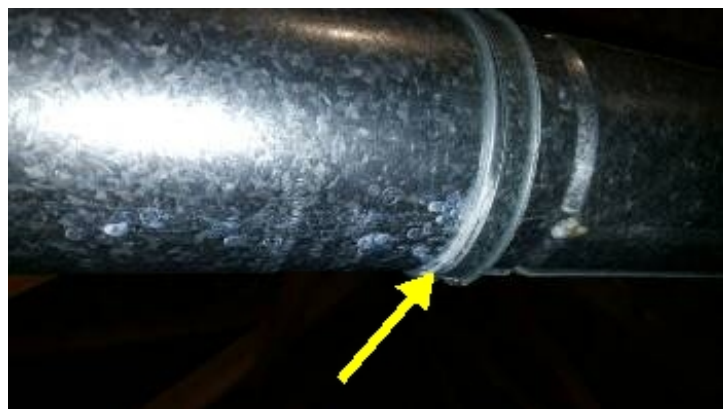
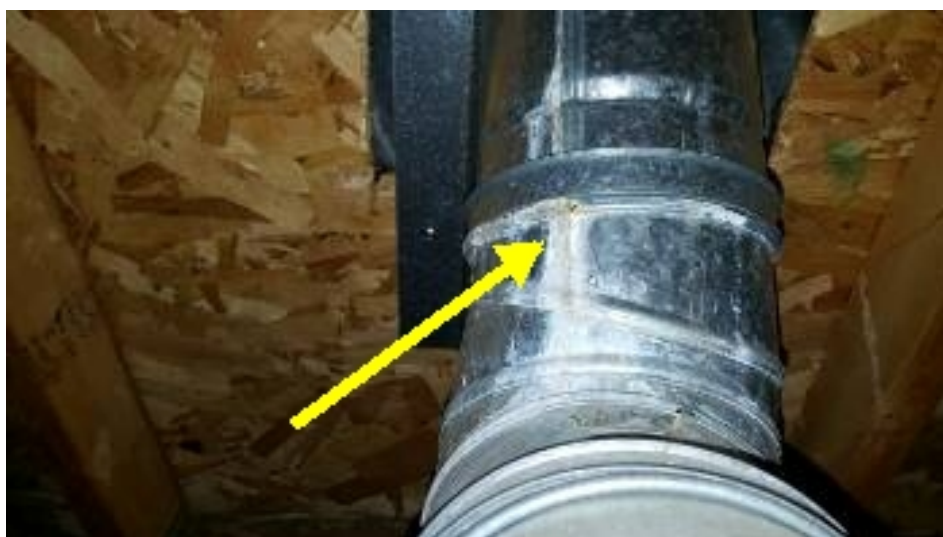
- Appears satisfactory with concerns of leaks at the seams of the flue piping.
- Evidence of previous leaks noted to the vent pipe in the attic area around the seams , no leaks noted today , however check with the seller for additional information about these leaks and had leaks in the past from this area around the vent pipe , insulation is moved away and a bucket is in the attic area below /around the vent pipe , this area should be closely monitored in the winter time and have a qualified HVAC contractor check and evaluate the piping to determine if any remedies or repairs are needed to prevent possible leaks from the vent pipe into the attic area

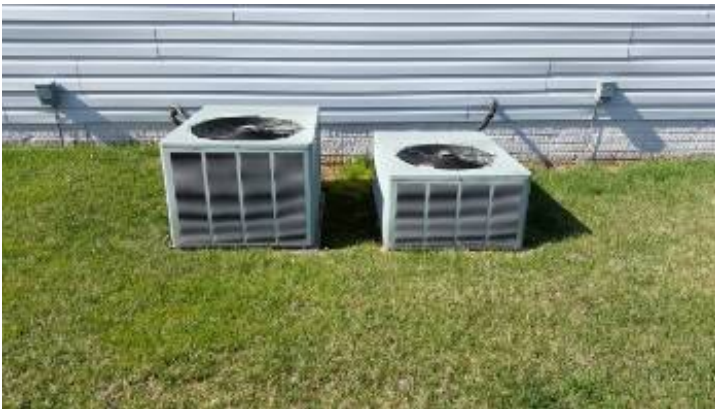
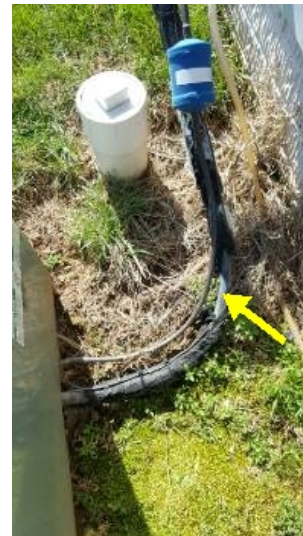
- Larger unit appears to service the 1st floor area.
- Maintenance Suggested
- Suggest to replace the insulation on the refrigerant lines on the outdoor unit.
- Outside temperature is below the safe operating temperature. Running the unit at temperatures below 65 degrees may damage the system. If you are concerned about the operation of the unit, it is highly recommended to purchase a home warranty that will cover the **A/C** unit.

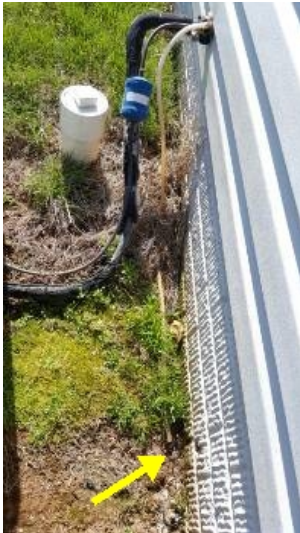
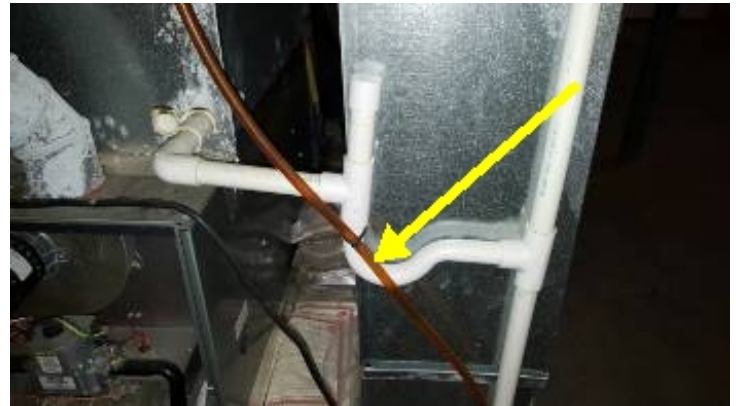
- Suggest to have the condensation line extended further away from the house as discussed.
- Evidence of previous leaks around the furnace area possibly from previous condensation leaks. Stains were dry at time of inspection, did not test the A/C unit due to colder exterior temperatures. Suggest to closely monitor this area and make any necessary repairs to the condensation line/pump lines if needed to ensure the water tightness.
- Suggest to clean the trap in the A/C line in basement and then maintain the trap every season to ensure the proper flow, put vinegar into the trap once a year to keep the trap cleaned for better performance

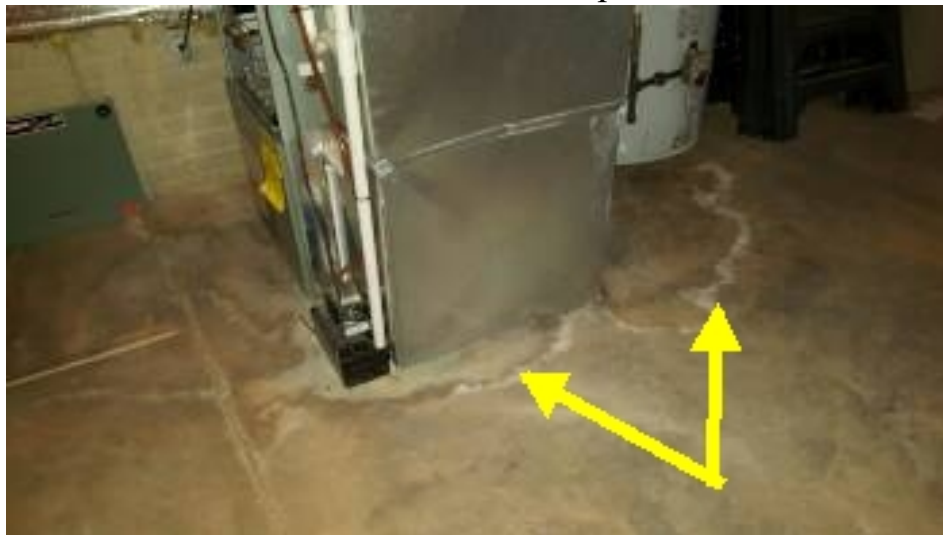
Trap should be cleaned and maintained

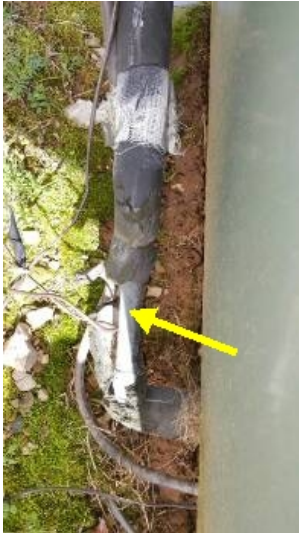
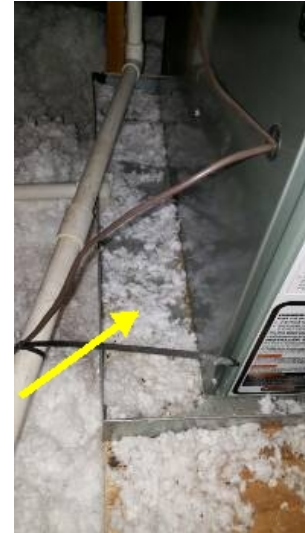
- Maintenance Suggested
- Suggest to replace the insulation on the refrigerant lines on the outdoor unit.
- Outside temperature is below the safe operating temperature. Running the unit at temperatures below 65 degrees may damage the system. If you are concerned about the operation of the unit, it is highly recommended to purchase a home warranty that will cover the A/C unit.

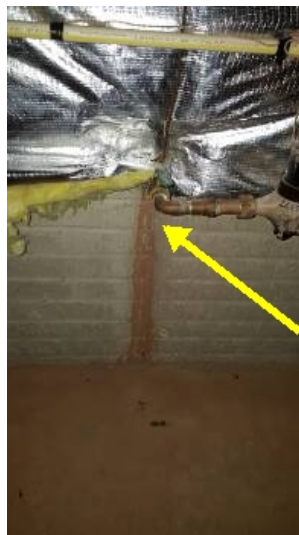
- Appear Satisfactory
- Evidence of previous leak noted below the main water line where it enters the foundation wall , the stain was dry at the time of the inspection , Suggest to check with the seller for additional information about these stains and previous leaks, Suggest to have the area around the pipe properly sealed to prevent the any future water penetration around the pipe where it exits through the foundation wall by a qualified contractor or as needed

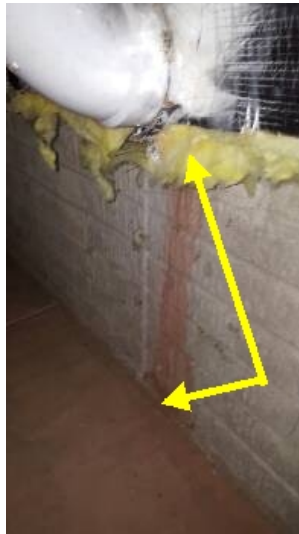
- Appears satisfactory
- Lines not fully visible
- Evidence of previous leak noted below the main waste line where it exits the foundation wall , the stain was dry at the time of the inspection , Suggest to check with the seller for additional information about these stains and previous leaks, Suggest to have the area around the pipe properly sealed to prevent the any future water penetration around the pipe where it exits through the foundation wall by a qualified contractor or as needed

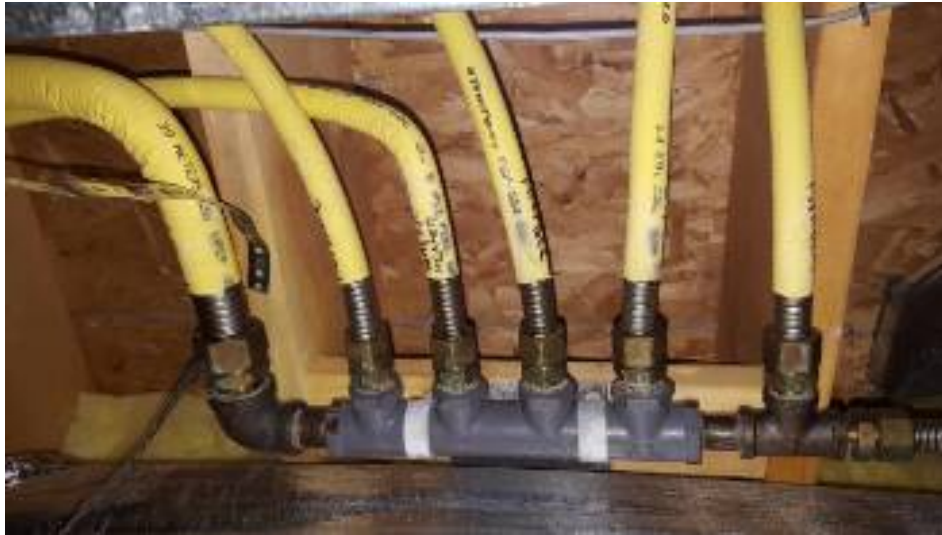
- Appears Satisfactory with concerns of having **CSST** gas lines installed.
- Fuel lines are not fully visible
- CSST (corrugated stainless steel tubing). These type of gas lines are a stainless steel flex line with a yellow coating that are installed within the interior of the home. These types of gas lines may be subject to damage or gas leaks if the gas meter or lines are struck by lightning. Therefore, the local gas companies are recommending that when these type of gas lines are installed within the home, the main gas line must be properly bonded/grounded (house side of meter) with the main electrical service prior to switching over to this yellow CSST line. Suggest to have a qualified electrician familiar with the bonding/grounding of these type of gas lines to ensure the proper protection of the CSST gas lines.

CSST gas lines within the home

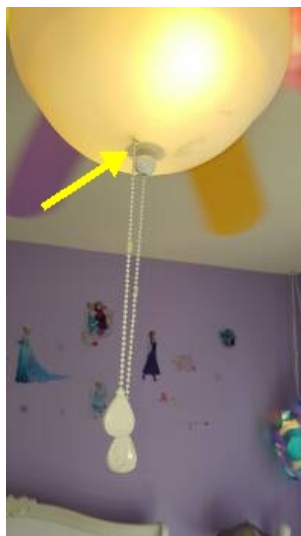
- Appears Satisfactory
- A representative sampling of switches and outlets was tested. Not all outlets were tested due to stored material and sellers belongings. As a whole, outlets and switches throughout the house are in satisfactory condition.
- Pull chain glide is broken in front right bedroom, suggest repairs for proper operation of the pull chain

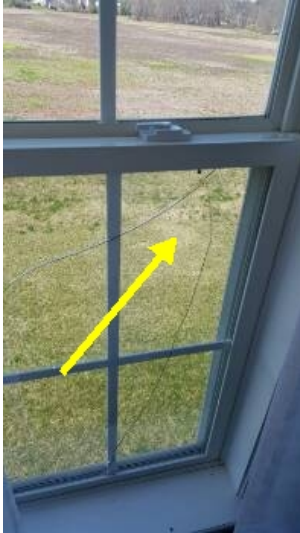
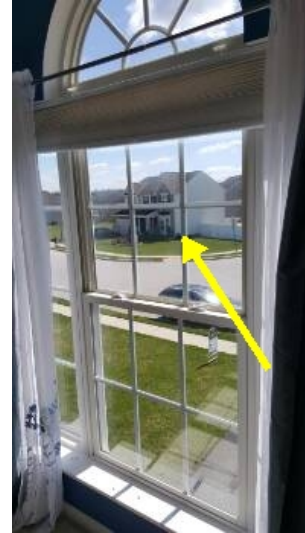
- Frosted window(s)(blown seals) found at the front windows in the master bedroom. This is an indication that the thermal seal of the insulated window has been compromised and moisture is now collecting between two panes of glass. Suggest to have a qualified window contractor make upgrades or repairs to the windows to ensure proper R value and prevent fogging /condensation between the panes
- **Suggest Repairs.**
- **Broken window/cracked glass in the master bedroom along the left side , Suggest repairs/ upgrades by a qualified window contractor**

Blown window seal

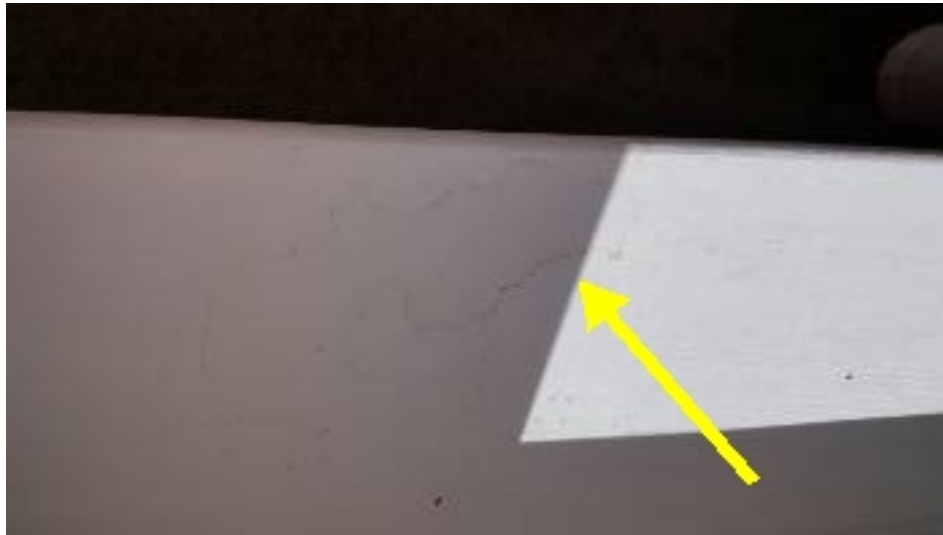
There was some minor water stains noted on the window sill in the front right sitting room , te stains were dry and may have been from leaving the windows up during a rain storm , however check with the seller about the stains and any previous issues of leaks in and around the windows , suggest to monitor the areas. Al front windows do appear to have been recently caulked and sealed around the trimmed areas

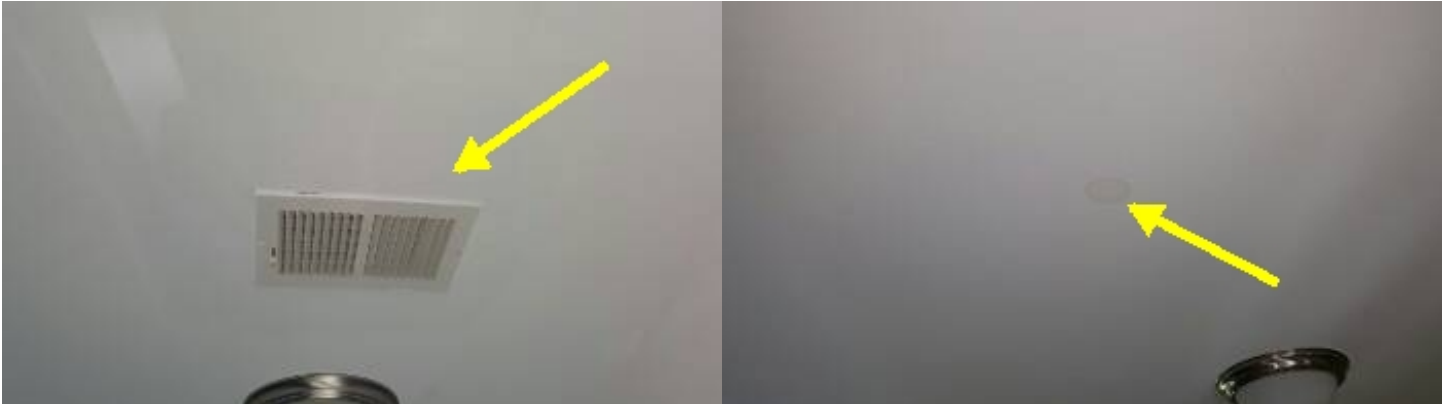
- Appears Satisfactory
- Typical / common cracks noted in some areas throughout
- There is a moisture stain noted around the ceiling HVAC vent in the master bedroom along the front area and also in the 2nd floor hallway ,The stains were dry the time of inspection when checked with a moisture meter , however suggest you check with the homeowner for more information about the stains and continue to monitor the areas for any future issues. Suggest and Expect future upgrades / repairs to this area if necessary

Stain around the vent in the master bedroom ,  
suggest to leave the HVAC fan in the on  
position during the A/C season to eliminate the  
build up of condensation around the ceiling  
vents

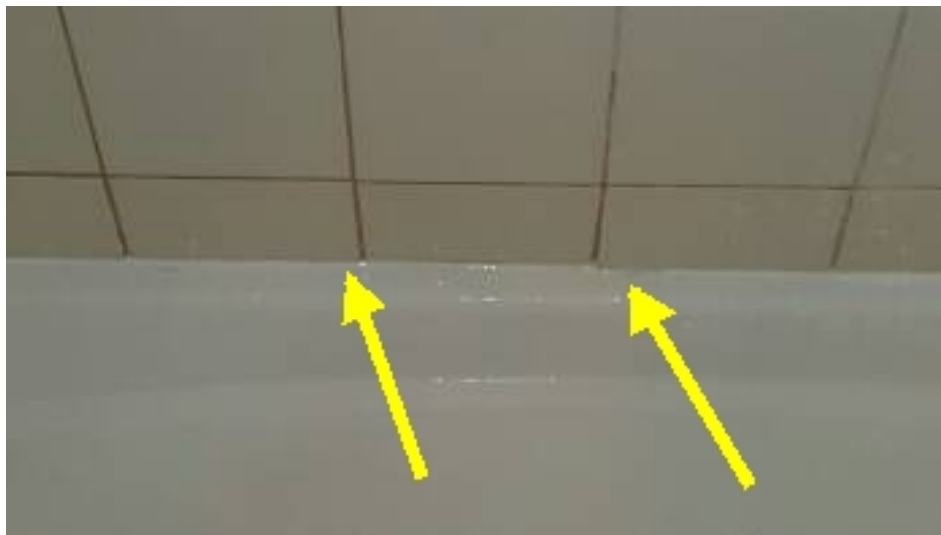
- Appears satisfactory
- Maintenance Suggested
- Suggest to seal around the shower tile at the bottom where the tile meets the floor/shower pan to prevent water penetration behind the wall.

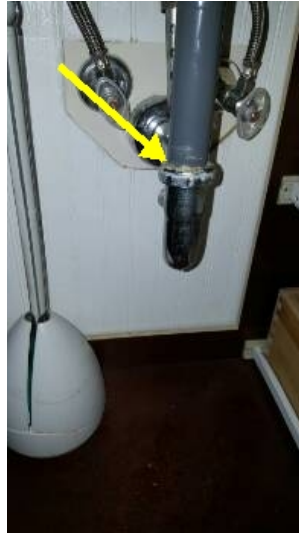
| Page 36 | SINK CONDITION | <ul style="list-style-type: none"> <li>• Suggest Repairs</li> <li>• Leak under sink at drain line connections. Suggest repairs by a qualified plumber to ensure water tightness and integrity of the waste lines.</li> </ul> |

- **Suggest Repairs**
- **Leak under sink at drain line connections. Suggest repairs by a qualified plumber to ensure water tightness and integrity of the waste lines.**

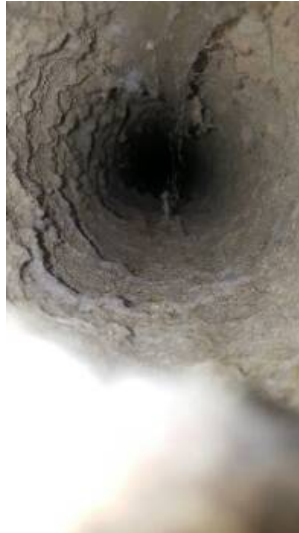
- Vent needs cleaning. Dryer vents must remain free of lint build up as this can be a fire hazard. Dryer vents should be kept clean and free from lint buildup. Suggest to have the dryer vent cleaned and serviced on an annual basis to ensure the proper venting of the dryer
- Suggest to monitor the hook ups when 1st using the units to ensure he proper function , draining the the connections and units
- The appliances do not convey with the home , Therefore the units were not tested

Inside pic of the dryer vent , vent should be cleaned and serviced
